Effects of Post Annealing and Oxidation Processes on the Removal of Damage Generated during the Shallow Trench Etch Process

In this study, 0.3–0.5 μm deep silicon trenches were etched using $\text{Cl}_2/10\%\text{N}_2$ and $\text{Cl}_2/50\%\text{HBr}$ inductively coupled plasmas, and the defects remaining on the etched silicon trench surfaces and the effects of various annealing and oxidation on the removal of the defects were studied. High resolution transmission electron microscopy was used to investigate the degree of remaining defects and X-ray photoelectron spectroscopy was also used to investigate surface contamination of the etched silicon wafers. Defects were found on the silicon trench surfaces etched using both $\text{Cl}_2/10\%\text{N}_2$ and $\text{Cl}_2/50\%\text{HBr}$. A thermal oxidation of 200 \AA at the temperature up to 1,100°C did not remove the remaining defects completely and more defects were remained on the silicon trench etched using $\text{Cl}_2/10\%\text{N}_2$. More defects remaining on the oxidized silicon trench for $\text{Cl}_2/10\%\text{N}_2$ appear to be related to the formation of silicon oxynitride on the silicon trench etched in $\text{Cl}_2/10\%\

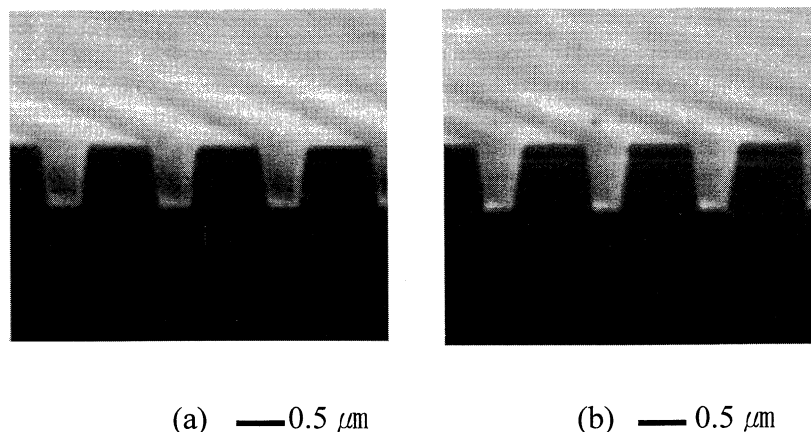
Fig. 1. Etch profiles of 0.3- μm -wide silicon trenches etched with (a) $\text{Cl}_2/10\%\text{N}_2$ and (b) $\text{Cl}_2/50\%\text{HBr}$. Process conditions: 10 mTorr, 400 W inductive power and -100 V bias voltage.

Silicon shallow trench etching using inductively coupled Cl_2/HBr and Cl_2/N_2 plasmas has been investigated as a function of gas combination, inductive power, and bias voltage and is described in details elsewhere.⁸⁾ In case of the trench etch profiles, the addition of HBr (50%) and N_2 (10%) to chlorine has improved the etch profile and the etch profiles of the silicon etched in $\text{Cl}_2/10\%\text{N}_2$ and $\text{Cl}_2/50\%\text{HBr}$ using 400W inductive power, -100 V of dc-bias voltage, and 10 mTorr of operational pressure are shown in Figs. 1(a) and 1(b), respectively.

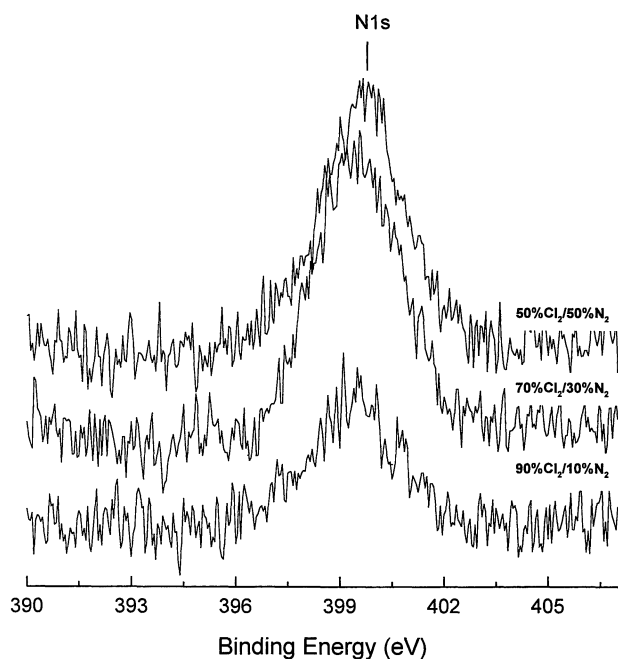
Fig. 3. XPS narrow scan spectra of N 1s peak etched using $\text{Cl}_2/10\%\text{N}_2$, $\text{Cl}_2/30\%\text{N}_2$, and $\text{Cl}_2/50\%\text{N}_2$.

To study the reason for the thicker damage remaining on the silicon trench etched using $\text{Cl}_2/10\%\text{N}_2$ after the same oxidation process, a blank silicon wafer was etched using $\text{Cl}_2/10\%\text{N}_2$ while other etch parameters were kept the same as the silicon trench etch condition and the etched silicon surface was examined using XPS. The result is shown in Fig. 3. XPS data examined for the silicon wafers etched using $\text{Cl}_2/30\%\text{N}_2$ and $\text{Cl}_2/50\%\text{N}_2$ were also included as a comparison. As shown in Fig. 3, all of the etched wafers showed a

N 1s peak on the etched silicon surface. The atomic percent of nitrogen found on the silicon surface was about 2% for $\text{Cl}_2/10\%\text{N}_2$, and about 4% for $\text{Cl}_2/30\%\text{N}_2$ and $\text{Cl}_2/50\%\text{N}_2$. The binding energy of N 1s was corrected using a C 1s peak (284.5 eV) and was 399.4 ± 0.3 eV. It is reported that N 1s XPS peak from N-Si₃ bonding is located at 397.7 ± 0.2 eV and that from SiO_xN_y bonding is at 399.6 ± 0.2 eV⁹⁾. Therefore, the N 1s peak found on the silicon surface etched using Cl_2/N_2 appears to be from SiO_xN_y. The source of the oxygen found on the silicon is partially from air exposure, however, it is more attributable from the oxygen emitted from the ICP quartz window even though no oxygen was added to the etch gas mixture. The ICP window required for generating inductively coupled plasmas in our etch system is eroded during the etching due to the high voltage generated on the ICP coil.

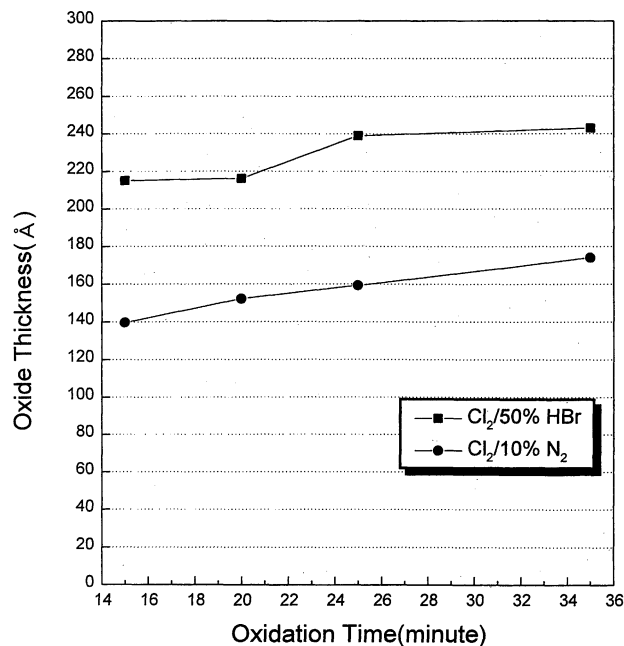
Fig. 4. Oxide film growth as a function of oxidation time (900°C, O₂) on etched silicon surfaces with 90% $\text{Cl}_2/10\%\text{N}_2$ and 50% $\text{Cl}_2/50\%\text{HBr}$.

Blank silicon wafers etched using the silicon trench etch conditions ($\text{Cl}_2/10\%\text{N}_2$ and $\text{Cl}_2/50\%\text{HBr}$) were oxidized at 900°C in O₂ for different time periods and the thickness of the grown oxide was measured, and the result is shown in Fig. 4. The thickness of thermal oxide grown on the silicon wafers etched using $\text{Cl}_2/10\%\text{N}_2$ was much thinner than that for $\text{Cl}_2/50\%\text{HBr}$ and the thickness of oxide grew with increasing oxidation time for both of the cases indicating some kind of mechanism blocking the oxidation for $\text{Cl}_2/10\%\text{N}_2$ at the initial stage of oxidation. The mechanism appears to be related to Si-O-N bondings found on the silicon surface in Fig. 3 because silicon oxynitride is possibly oxidized slower than silicon. In fact, silicon nitride is generally used for the oxidation mask for the conventional LOCOS process due to the about 20 times slower oxidation of silicon nitride compared to the oxidation of silicon. Therefore, the thin silicon oxynitride formed on the silicon surface during the etching with $\text{Cl}_2/10\%\text{N}_2$ could also block the oxidation of silicon similar to silicon nitride even though the oxidation of silicon oxynitride is faster than conventional silicon nitride. Even though the analysis in Fig. 3 and Fig. 4 were done with blank silicon

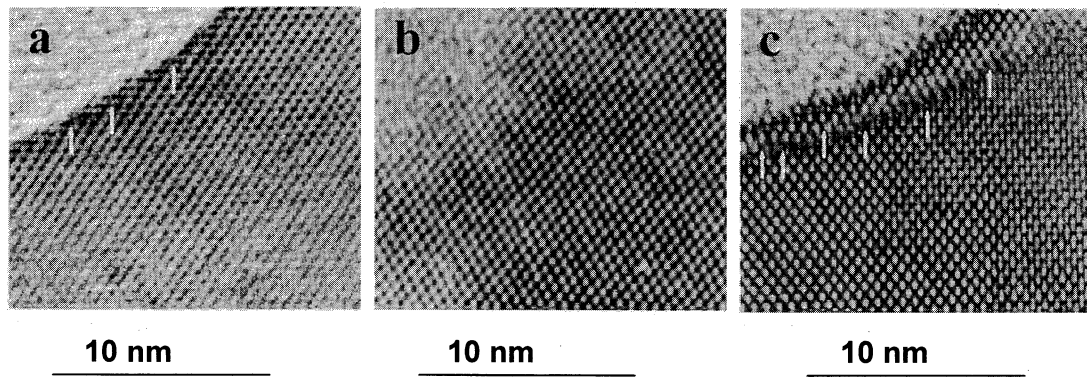
Fig. 5. High resolution TEM micrographs of the silicon trench bottom edges annealed at 1000°C in N_2 for 30 min after the etchings. (a) 1,000°C anneal after the etching in 90% Cl_2 /10% N_2 , (b) 1,000°C anneal after the etching in Cl_2 /50%HBr and (c) 900°C anneal after the etching in 90% Cl_2 /10% N_2 .

Figures 5(a) and 5(b) shows HRTEM micrographs of the silicon trenches annealed at 1,000°C for 30 min in N₂ after the etchings using (a) $\text{Cl}_2/10\%\text{N}_2$ and (b) $\text{Cl}_2/50\%\text{HBr}$. The silicon trench annealed after the etching with $\text{Cl}_2/10\%\text{N}_2$ shows a clean silicon trench surface except one or two distorted atomic layers on the surface. In case of the silicon trench annealed after the etching with $\text{Cl}_2/50\%\text{HBr}$, a defect-free clean silicon trench surface was obtained. Silicon trenches annealed at 900°C after the etching with $\text{Cl}_2/10\%\text{N}_2$ were also observed using HRTEM and are shown in Fig. 5(c). As shown in the figure, physical defects were still remained and

more defects were observed compared with the annealing at 1,000°C shown in Fig. 5(a) due to the lower annealing temperature. From the results from Fig. 5, to completely remove the defects formed on the etched silicon trenches by annealing, the annealing above 1,000°C for 30 min in N_2 appears to be required.

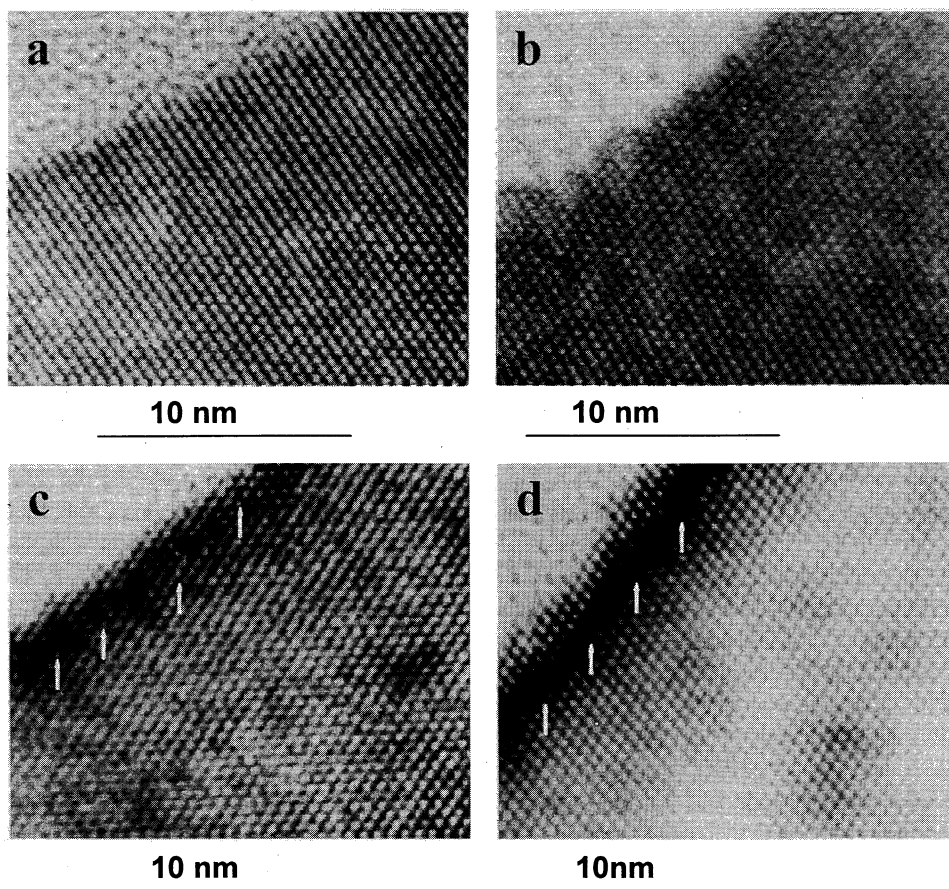
Fig. 6. High resolution TEM micrographs of the silicon trench bottom edges annealed in N_2 for 30 min followed by thermal oxidation of 200 Å in O_2 at 900°C after the etchings. (a) 1,000°C anneal after the etching in Cl_2 /50%HBr, (b) 1,000°C anneal after the etching in 90% Cl_2 /10% N_2 , (c) 900°C anneal after the etching in Cl_2 /10% N_2 and (d) 900°C anneal after the etching in Cl_2 /10% N_2 .

50%HBr, therefore, after removing most of defects formed during the etching by annealing, the silicon trenches were oxidized at 900°C in O_2 to form 200 Å thick thermal oxide. HRTEM micrographs of these annealed and oxidized silicon trenches were observed and are shown in Fig. 6 for (a) Cl_2 /50%HBr and (b) Cl_2 /10% N_2 . As shown in the figures, clean silicon trench areas were obtained for both of the etching conditions. The etched silicon trenches were also oxidized at 900°C in O_2 after the annealing at 900°C for 30 min in N_2 , and the results are shown in Fig. 6(c) for Cl_2 /50%HBr

and Fig. 6(d) for $\text{Cl}_2/10\%\text{N}_2$. As shown in the figures, physical defects were still remained for both of the cases. Therefore, by the combination of appropriate annealing and oxidation processes, the damage formed during the trench etch processes could be completely removed.
